# Manhole Inspection Summary

Manhole # S07OO1032MH

Insp Date: **5/14/07 9:01 AM**

**Location** Address: **5011 ELMER AVE**

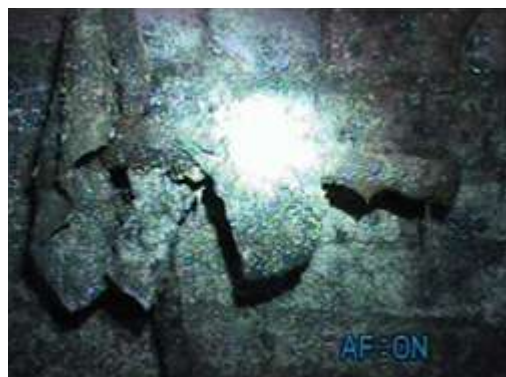
Defect 1

**Steps** Count: **5** Missing: **0** ☒ **Corroded**

**Surcharge** ☒ **Evidence Of Surcharge** Depth: **2.5** (ft.) ☐ Active Surcharge Present

CORRODED RUNG/ EVIDENCE OF SURCHARGE

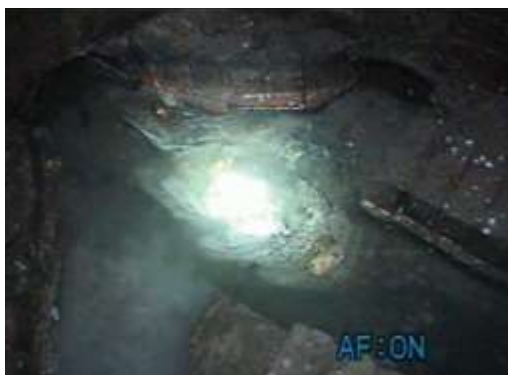
Defect 2

DEBRIS IN CHANNEL

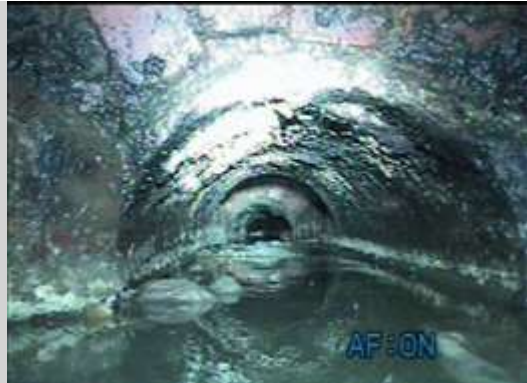
12 O'Clock Outflow

10 in. Circular Gravity Sewer  
Pipe Out @ 12 O'Clock

Pipe Height: (in.) Direct  
Pipe Material: **Clay** ☐ Pipe Lined  
Invert Depth: **8.88** (ft.) Flow Characteristics: **Slow**  
Deposits: ☒ None ☐ Mud ☐ Sludge ☐ Debris ☐ Grease  
Silt Depth: (in.) Deposits Extent:  
Infiltration: **None** Pipe Seal Cond: **Unknown**

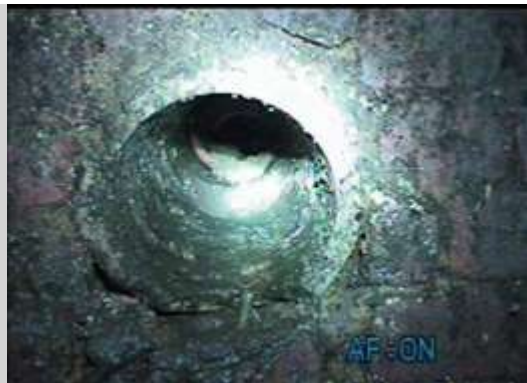
3 O'Clock Inflow

8 in. Circular Gravity Sewer  
Pipe In @ 3 O'Clock

Pipe Height: (in.) Direct  
Pipe Material: **Clay** ☐ Pipe Lined  
Invert Depth: **7.43** (ft.) Flow Characteristics: **None**  
Deposits: ☒ None ☐ Mud ☐ Sludge ☐ Debris ☐ Grease  
Silt Depth: (in.) Deposits Extent:  
Infiltration: **None** Pipe Seal Cond: **Sound**

Drop: **Outside Direct**  
Angled: Reading: (ft.)  
Inv Depth: **8.84** (ft.)  
Drop Condition: **Open**

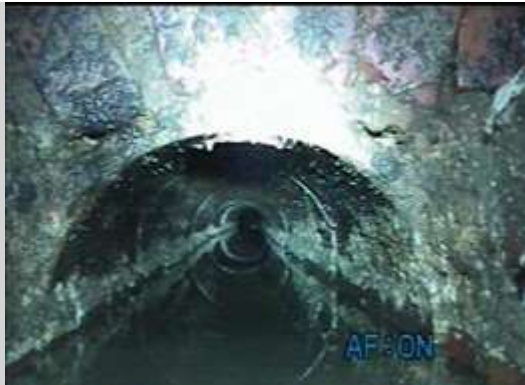
6 O'Clock Inflow

10 in. Circular Gravity Sewer

Pipe In @ 6 O'Clock

Infiltration: **None** Pipe Seal Cond: **Sound**

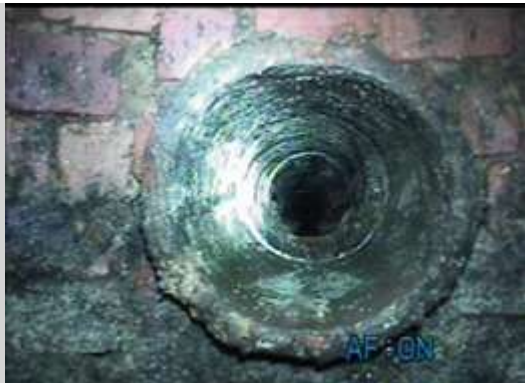
9 O'Clock Inflow

8 in. Circular Gravity Sewer

Pipe In @ 9 O'Clock

Infiltration: **None** Pipe Seal Cond: **Unknown**

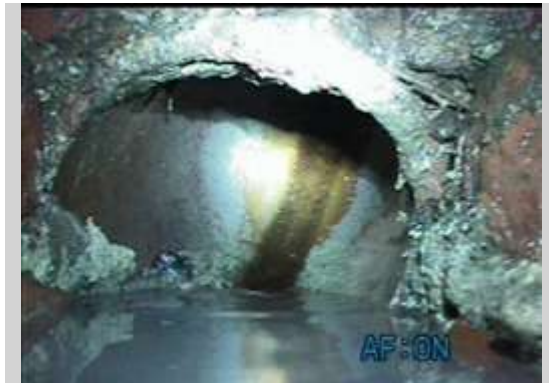
Drop In @ 9 O'Clock

Drop: **Outside Direct**

Inv Depth: **8.82** (ft.)

Drop Condition: **Open**
